# HISAKA PLATE HEAT EXCHANGER MAINTENANCE GUIDE

## Forward

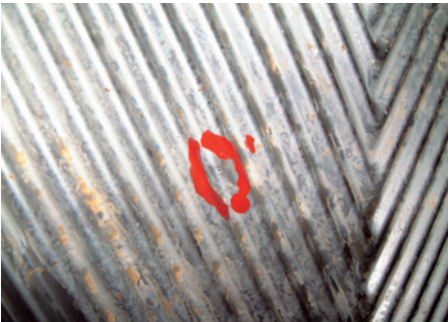
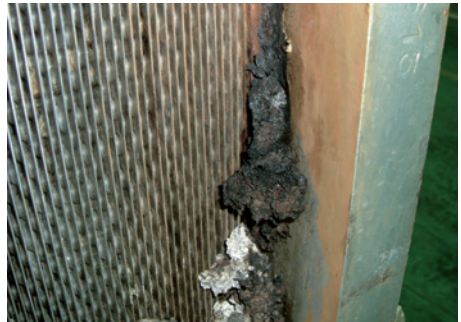
↑ Cracking visual inspection (top)  
Cracking detection by dye penetration test (bottom)

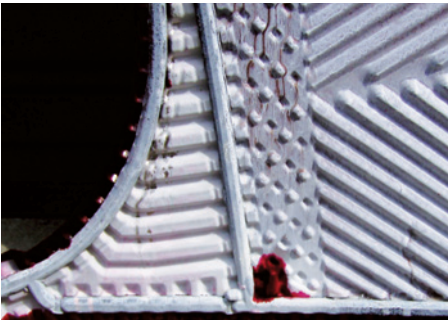
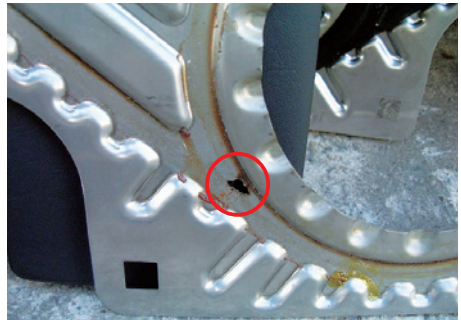
↑ Heat exchanger left alone without changing the gasket (top), crevice corrosion occurring at the gasket line (bottom)

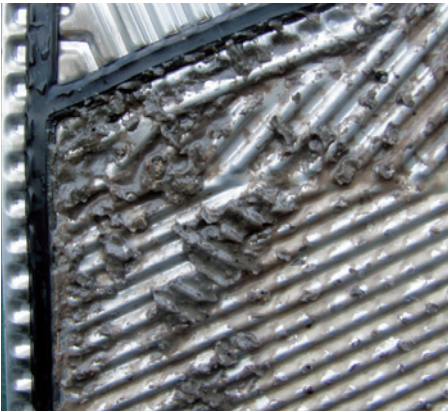
↑ Scale accumulated on the plate surface

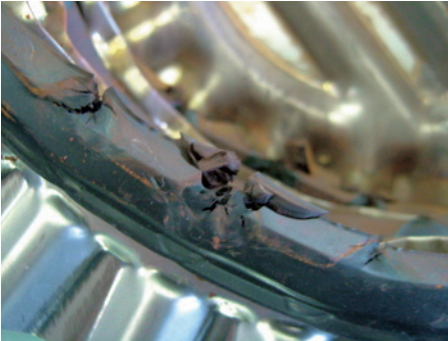
Although high quality synthetic rubber is used for gaskets, deterioration due to aging is still unavoidable. Deterioration such as loss of elasticity, cracking or carbonization for rubber will decrease the sealing force, and will cause fluid leakage.

↑ Deteriorated gasket

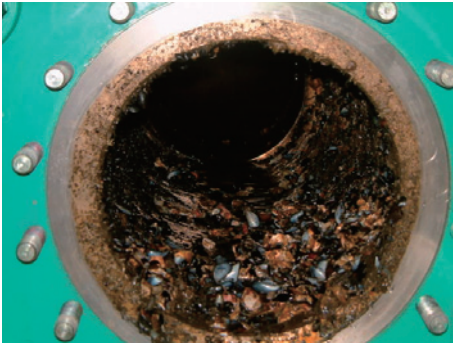
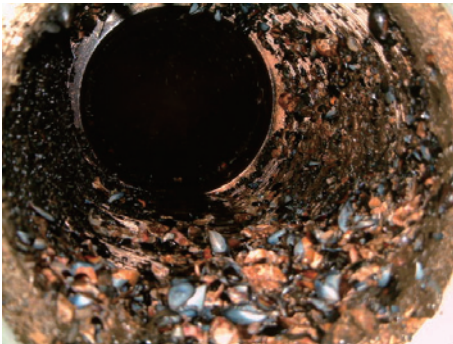
↑ **Heat exchanger Seawater inlet port hole**  
Wood chips, seaweeds and shellfish are blocking the flow channel, and causing poor flow in the unit.

Because of this, many plants periodically perform disassembly cleaning (generally once a year), but this is time consuming and costly. Therefore, as an anti-fouling system, HISAKA recommends using a combination with "Hot water circulation" system in which hot water is circulated for a certain amount of time, and "Air bubbling" in which compressed air is blown through the heat exchanger.

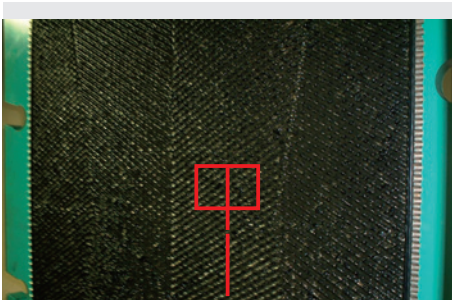
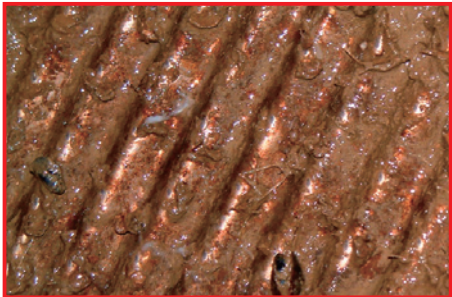
← **Plate heat transfer surface**  
Slim and ocean life have accumulated, and is causing poor heat transfer.

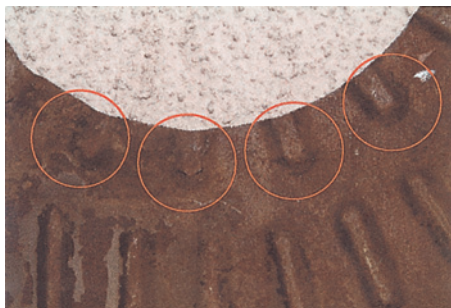
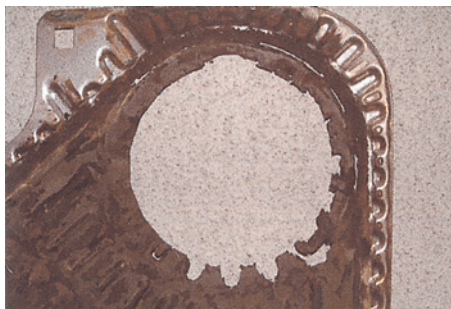
- Operating time...Approx. 8 years
- Plate material...SUS316 (Stainless Steel 316)
- Duty...Chromium acid plating fluid/ cooling water
- Operating temperature...30°C
- Cause...Plate material is less corrosion resistance.
- Action and correction...After 8 years operation without fault, and is still possible to operate. But, it is necessary to increase the plate thickness, or change the material to titanium which is fully corrosion resistant, etc. A guideline of corrosion rate for material selection should be less than 0.1 mm/y.

↑ Magnified of the port hole of plating fluid side

↑ Port hole of plating fluid side

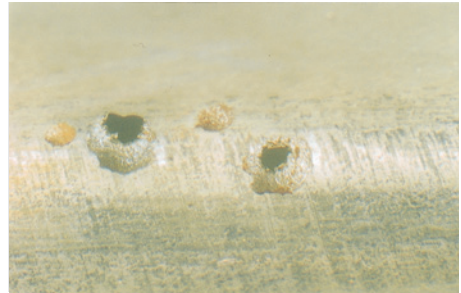
↑ Magnified of the corroded area

- Operating time...Approx. 1 year
- Plate material...SUS304 (Stainless Steel 304)
- Duty...Engine circulation cooling water/cooling water
- Operating temperature...90°C
- Cause...The  $\text{Cl}^-$  ion concentration in the circulating fluid was 50ppm which is not a concentration that would be corroded, but localized concentration of  $\text{Cl}^-$  between deposit of scale and plate surface causes pitting corrosion.
- Action and correction...It is necessary to grade up the steel grade to SUS316, etc., with increased Cr, and Mo added. Also, periodic disassembly inspection and regeneration of the passive film through scale removal, and water quality control for the fluid, are recommended.

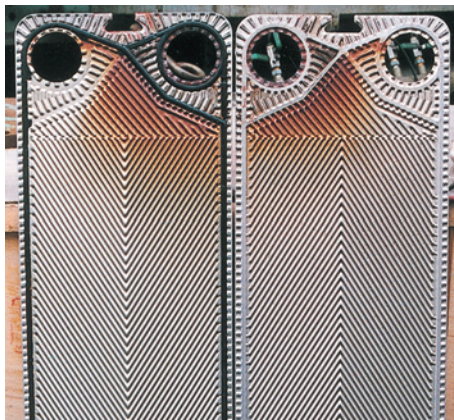
- Operating time...Approx. 5 years
- Plate material...SUS304 (Stainless Steel 304)
- Duty...Steam / city water
- Operating temperature...140°C
- Phenomenon...A tiny leak from the shoulder area of the plate on the steam side by deterioration of the gasket entered the double seal area of the plate, and with the concentration of  $\text{Cl}^-$  ions which are factors of corrosion, corrosion attacks penetrated the plate. Consequently, the city water leaked from the double seal area of plate.
- Cause...This is a pitting corrosion due to concentration of  $\text{Cl}^-$  ions, caused by leaving the tiny leakage from the steam side.
- Action and correction...Replace the gasket periodically, and change to higher grade plate material like SUS316, etc.

↑ Steam side

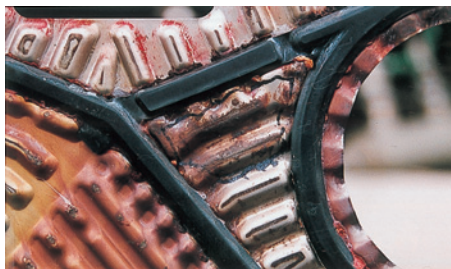
↑ Stress cracking (later noted) also occurred under rust deposit

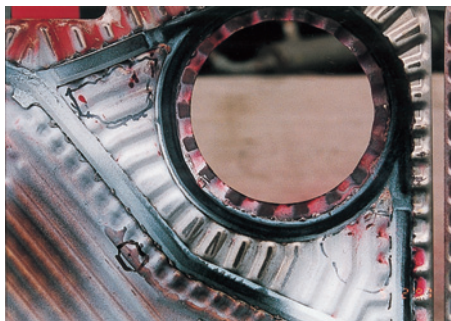
↑ Penetration cracking in red areas (the developing fluid by DPT)

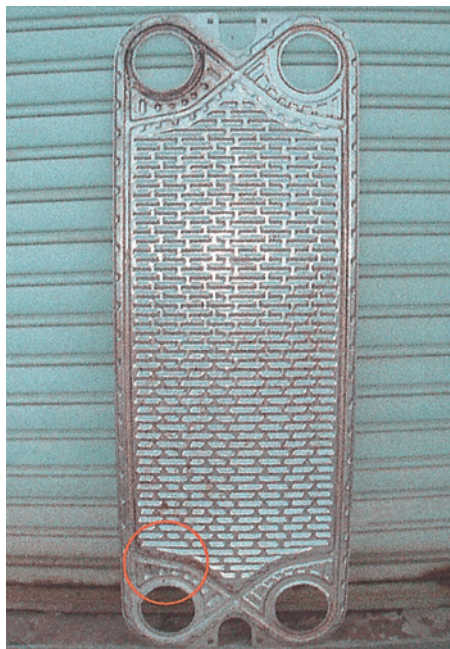
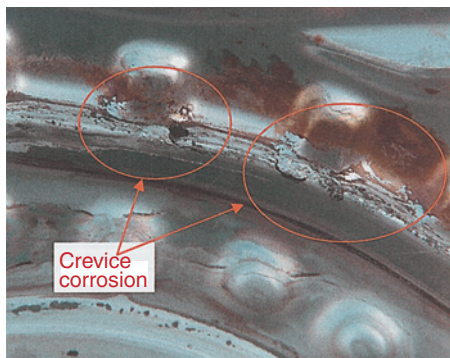
- Operating time...Approx. 6 months
- Plate material...Carpenter20 equivalent (High nickel Alloy)
- Duty...98% sulfuric acid / circulating cooling water
- Operating temperature...60°C
- Cause...It was found that the crevice corrosion is occurred by high concentration of  $\text{Cl}^-$  ions at the tiny gap between the cooling water side gasket and plate. Also in this case, as the crevice corrosion penetrated through the plate, 98%  $\text{H}_2\text{SO}_4$  and cooling water were mixed and changed to the dilute sulfuric acid. Consequently, dilute acid made general corrosion collaterally.
- Action and correction...It is necessary to change the plate material to HastelloyC equivalent, and improve control to prevent concentrating the  $\text{Cl}^-$  ion concentration in the cooling water.

↑ Cooling water side

↑ Magnified of the cooling water side

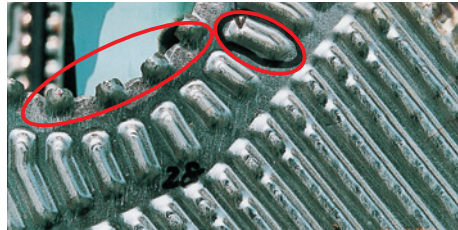
- Operating time...Approx. 4 years
- Plate material...TP270 (Ti) (Stainless Steel 304)
- Duty...20% NaOH / industrial water
- Operating temperature...30°C
- Phenomenon...A severe general corrosion, penetrating pit and fluid leaks were found at the wet surface of 20% NaOH side.
- Cause...Deep erosion corrosion was found around the plate to plate contact points and part, and it was judged that erosion corrosion had progressed.
- Action and correction...Decreasing of the fluid velocity by increasing the number of plates, and removal of the slurry, and in addition, using the thicker plate is recommended. It is also necessary to check the corrosion resistance of the plate material.

↑ Decreasing the plate thickness due to severe erosion corrosion

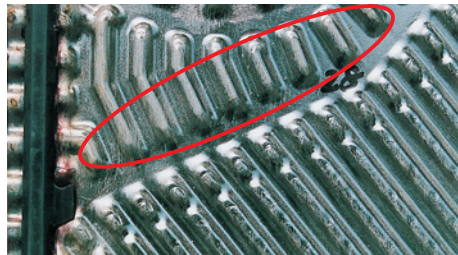
↑ Erosion corrosion at the plate contact points and near contact points

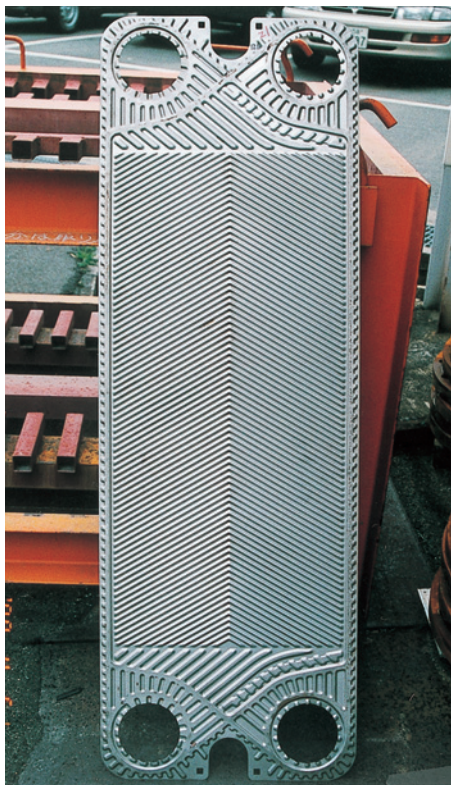
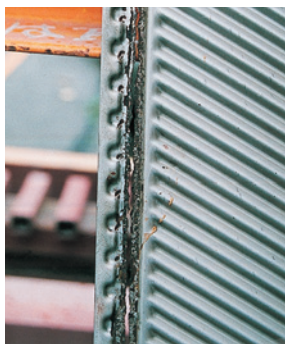
- Operating time...Approx. 2 years
- Plate material...SUS304 (Stainless Steel 304)
- Duty...Primary water / secondary water
- Operating temperature ... 90°C
- Phenomenon...There was an occurrence of rust deposit on the back side of the gasket, and a crack occurred at the gasket seal line.
- Cause...It is possible that when chloride ions in the fluid was exposed to high temperature conditions, it was concentrated at gasket areas where the flow rate is slow, and the plate was corroded here rapidly. The crack can be determined to be stress corrosion cracking due to the rust deposit occurrence and branch shape crack.
- Action and correction...Because the plate surfaces are also corroded, using SUS304 may be corroded by this water quality. We recommend to use the material to the molybdenum added SUS316, which is anti-chloride material.

↑ Plate

← Cracking at the gasket groove

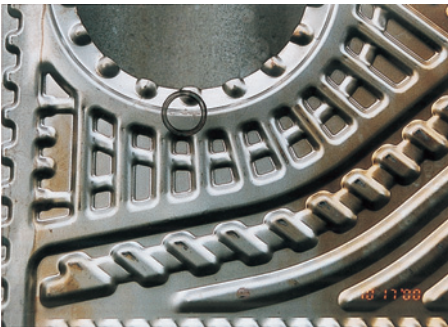
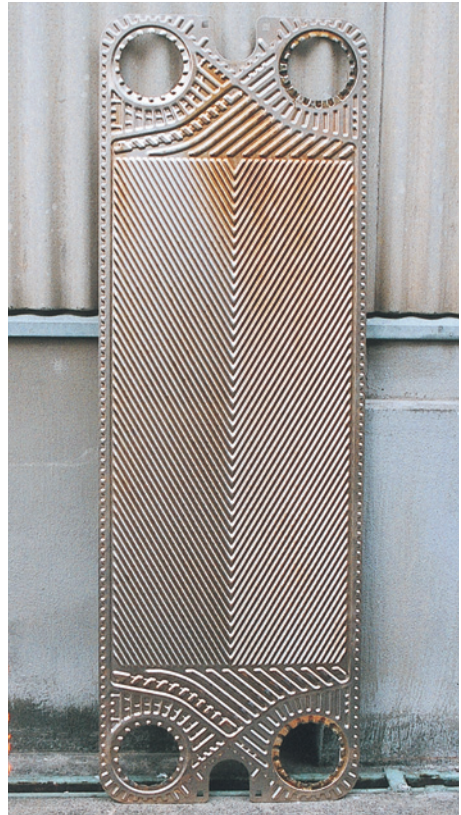
- Operating time...Approx. 3 years and 7 months
- Plate material...TP270 (Titanium 270)
- Duty...Mixed organic vapors / ethylene glycol solution
- Operating temperature...99°C
- Phenomenon...A crack occurred on the plate, and leakage was found.
- Cause...Used as a condenser for mixed organic vapors (toluene, methanol, acetone, etc.). It is supposed that a crack occurred due to the methanol in the vapors, and stress corrosion cracking occurred.
- Action and correction...Austenite type stainless steel is suited for methanol existing circumstance. We recommend changing material to the type to SUS316.

↑ Magnified of the vapor side

↑ Vapor side

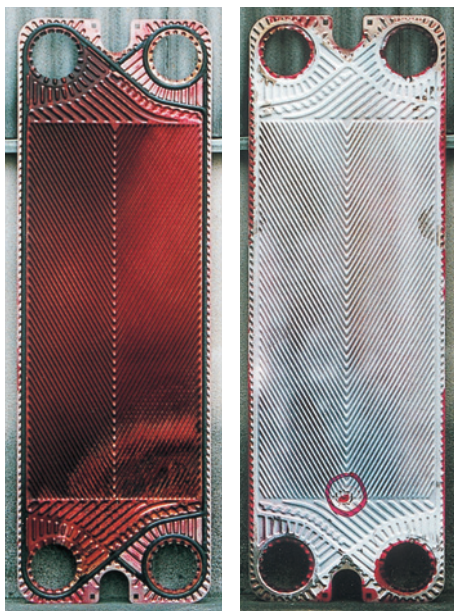
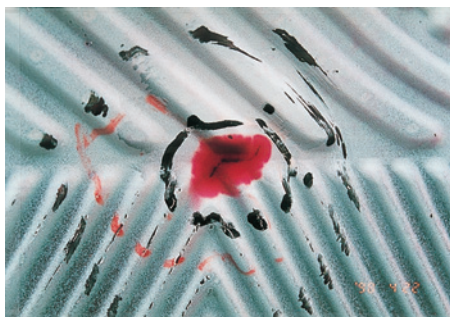
↑ Steam side (left)  
Thermo oil side (right)

- Operating time...Approx. 13 years and 8 months
- Plate material...SUS316 (Stainless Steel 316)
- Duty...Steam / thermo oil
- Operating temperature...130°C
- Phenomenon...When brine instead of steam and thermo oil was periodically used through the unit alternatingly, a inter-mixing of brine and thermo oil occurred. In the 5 plates, a crack was found near the end of the center of the heat transfer zone, at lower part of the plate.
- Cause...Because there are no traces of corrosion on the plates, and the position of the cracks of each plate is the same, and because this is a position where stress will concentrate and the load is high, fatigue crack is concluded to be the cause.
- Action and correction...It is concluded that fatigue crack occurred because this unit was used for long years. To increase the strength of the plates, a thicker plate is recommended.

↑ Magnified of the fatigue crack

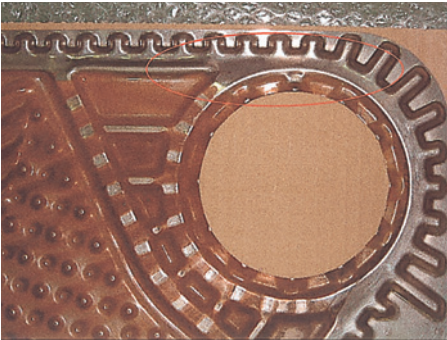
← Port hole (from the back side of the plate) can be seen to be severely deformed.

- Operating time...Approx. 13 years and 4 months
- Plate material...SUS316 (Stainless Steel 316)
- Duty...0.2MPaG steam / hot water
- Operating temperature...170°C
- Phenomenon...Deformation was found at the gasket groove of the plate on the hot water side.
- Cause...Because no corrosion or stress concentrations can be seen, water hammering made this damage.
- Action and correction...In this condition, the gasket cannot be compressed by plate deformation, and sealing is not possible. The plates were damaged, so all plates were replaced. It is necessary to improve the operating condition, to avoid water hammering.

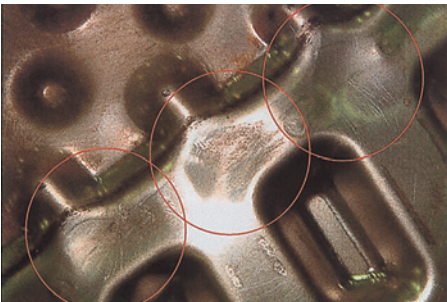
← It can be seen that the double seal area (from the back side of the plate) is hollowed.
