Forward

Thank you for choosing the HISAKA plate heat exchanger.

1— Construction of Plate Heat Exchanger Mechanism

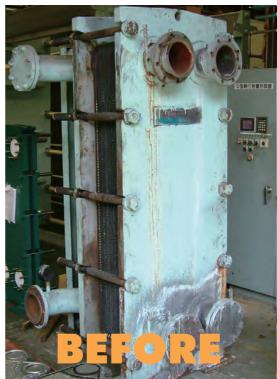
After completion of "Full Service package", the certified sticker is put on the unit. Records of maintenance and replaced parts are registered in the Hisaka database, and will be utilized in future maintenance.

1 Before work/after work

Flowchart of "Full Service package"

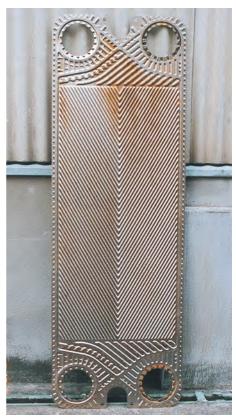
Vapor side

1 Magnified of the vapor side
